**LI TUNGSTEN
GLEN COVE, NEW YORK**

**INTERIM REMEDIAL ACTIONS
REVISED WORK PLAN**

December 1994

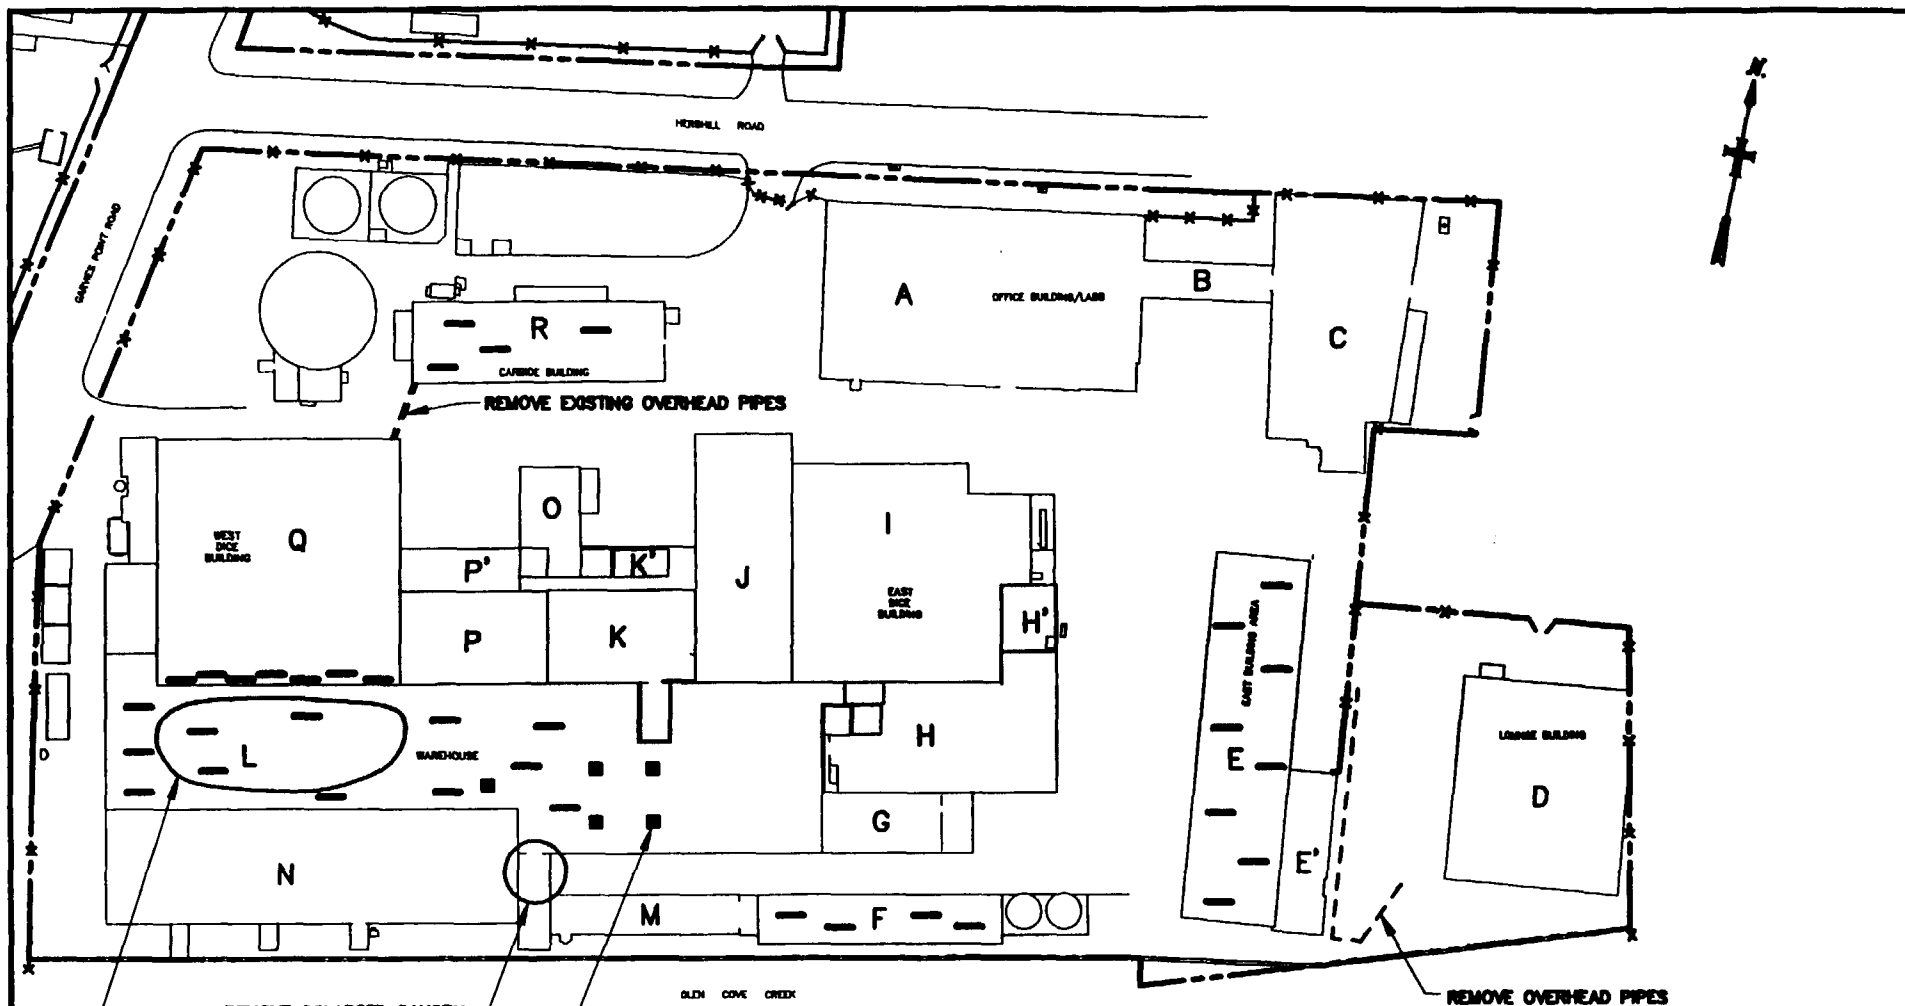
FIGURE 2-1

A walk-through inspection was performed of the buildings on Parcels A and C to evaluate the structural condition. Areas that are NOT considered to be structurally sound or areas

that require remedial action work are described in detail below and shown on Figures 2-1 and 2-2. Each building or building segment shown on Figures 2-1 and 2-2 has been assigned a letter designation (e.g., A, B, C, etc.). Results of the structural inspection including building material (roof, walls and floor) and condition are summarized in Table 2-1.

The remaining interim remedial action is to remove hanging pipe in those areas shown on Figure 2-1 (Parcel A, Buildings E', Q, and R) where overhead clearance will be required for access by drilling equipment (Refer to photographs #17, 34).

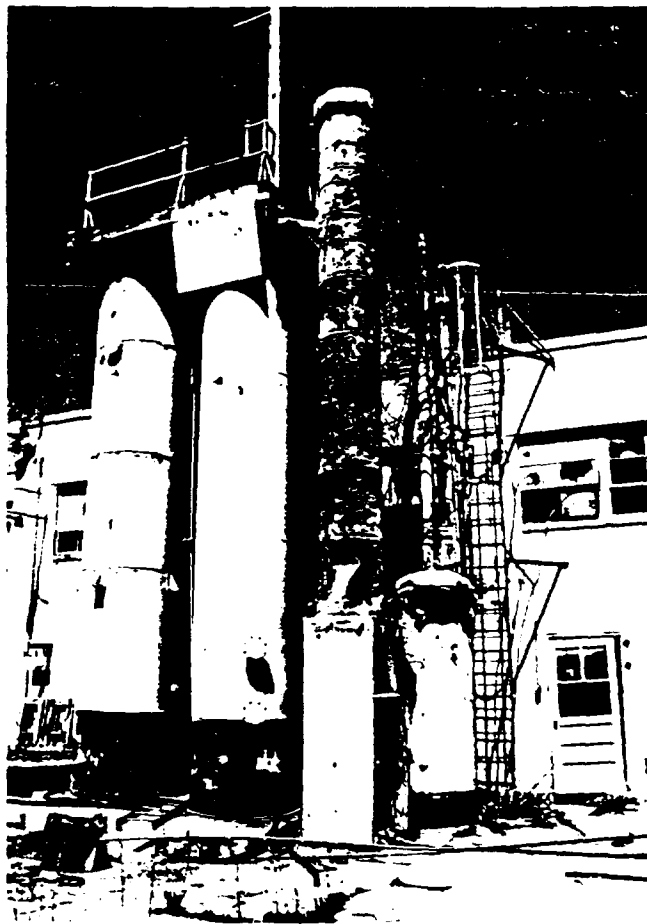
Photograph #21
Stripping Tower Insulation, 30 Inch
Area #70, Parcel "C"

- Install signs in Area 70 on Parcel C as shown on Sheet 2 indicating a restricted ACM area. Greater than 1000 linear feet of significantly damaged ACM piping insulation exists in this building.

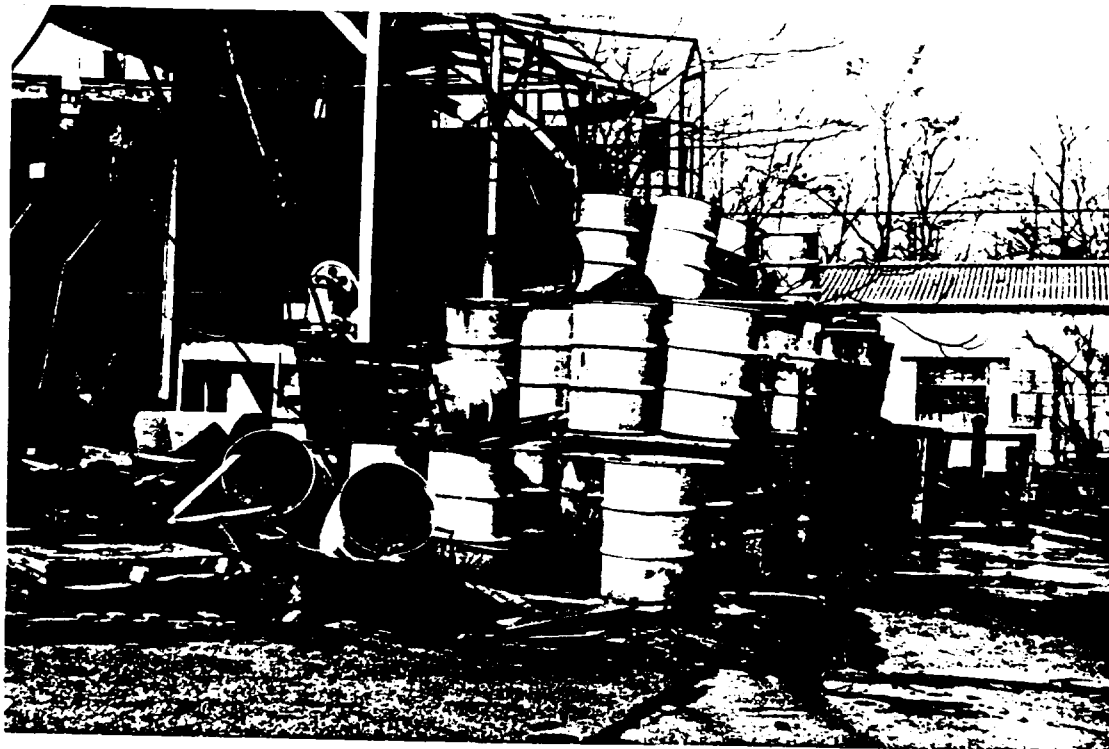
Photograph #31
Stockpiled Drums with Tungsten Ore
South of Building B

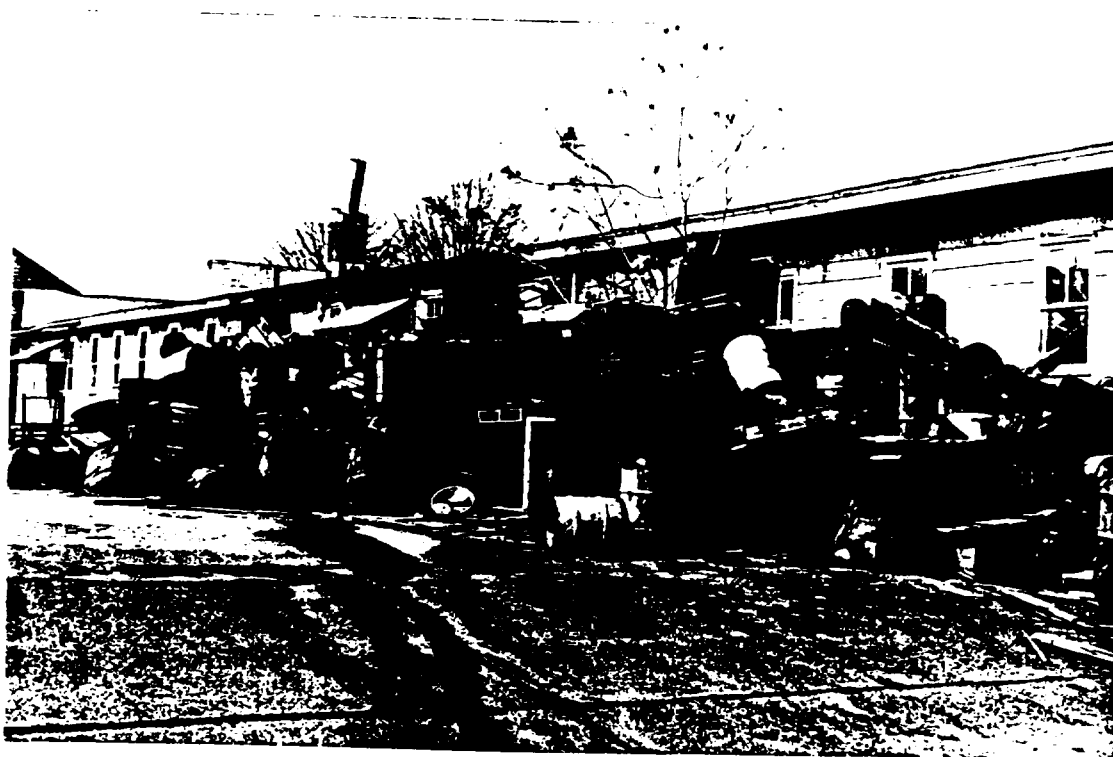
Photograph #32
Drum Debris
South of Building A

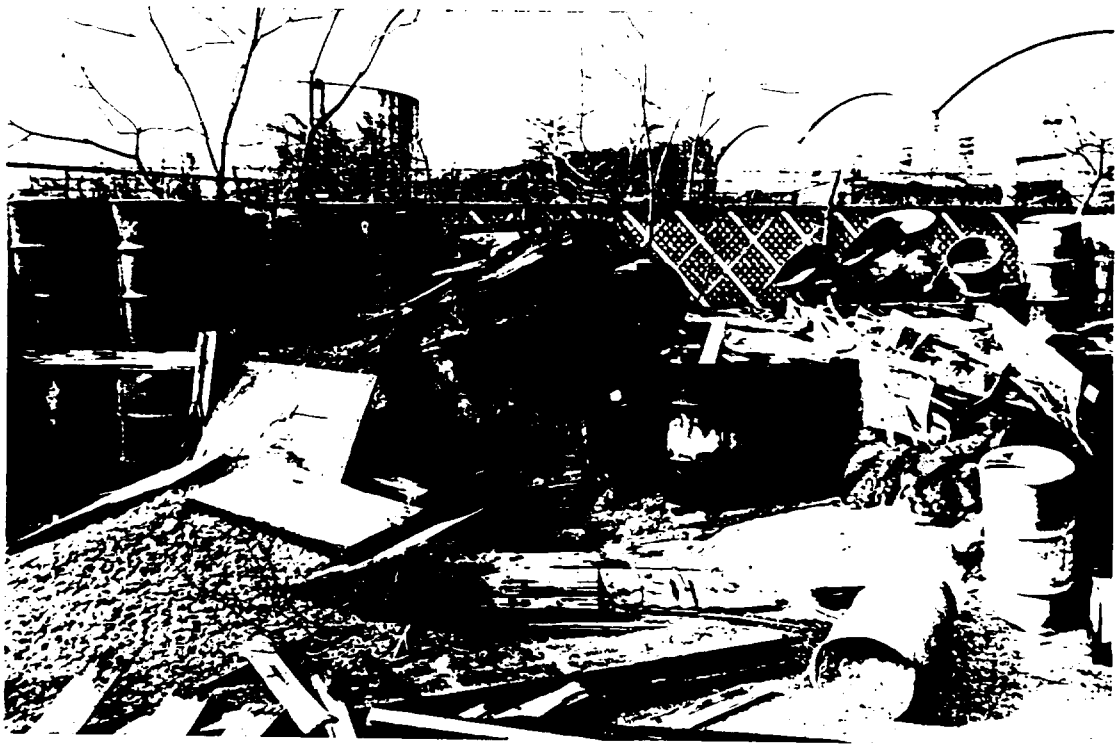
Many of the drums and crates located outside are weathered and have corroded or deteriorated to a point where the contents have spilled onto the ground (Refer to photograph #33). In other areas, the drums have been overstacked and have become very unstable due to deterioration and corrosion.

Photograph #33
Deteriorated Drums/Crates with Tungsten Ore
West Perimeter Property Line/Garvies Point Road

- Tungsten ore/slag contained within partially deteriorated drums or stockpiled material along the five (5) main exterior perimeter areas of Parcel A will be consolidated into 30 cubic yard roll-off containers. The roll-off containers may be filled with a front-end loader. Deteriorated drums can be segregated and stockpiled for decontamination and crushing prior to off-site disposal. Roll-off containers would then be loaded onto flat-bed trucks and transported to the Dickson Warehouse on Parcel C.

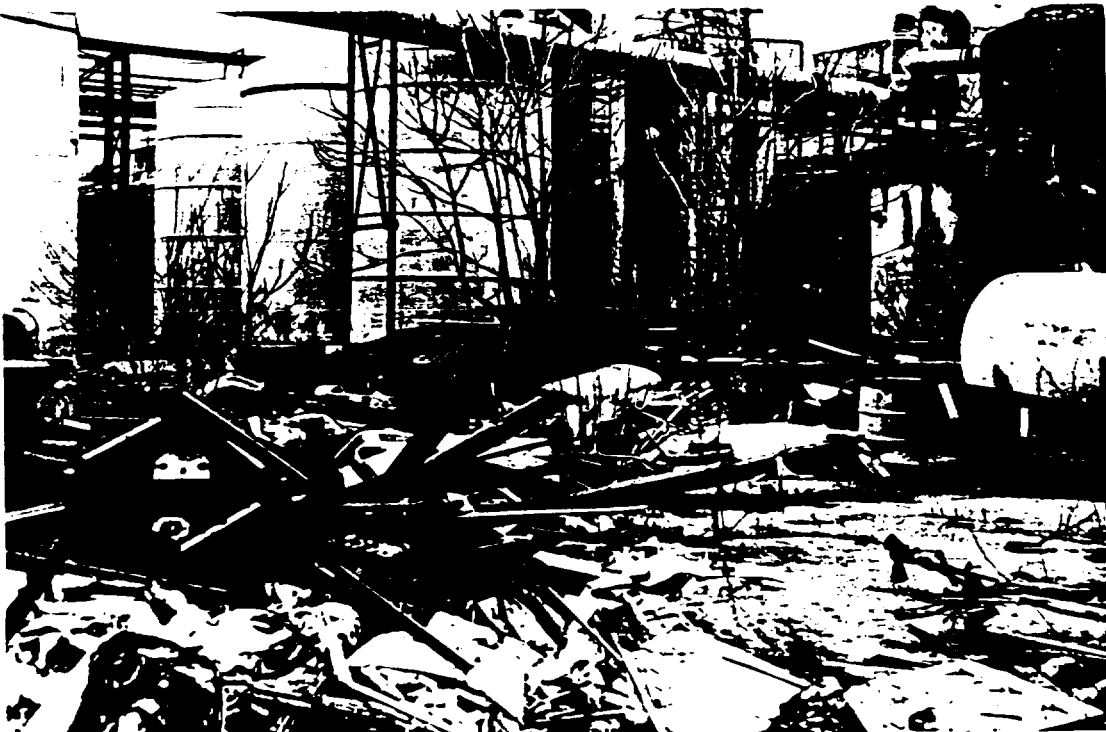
Photograph #39
C & D Debris
Outside of Building H

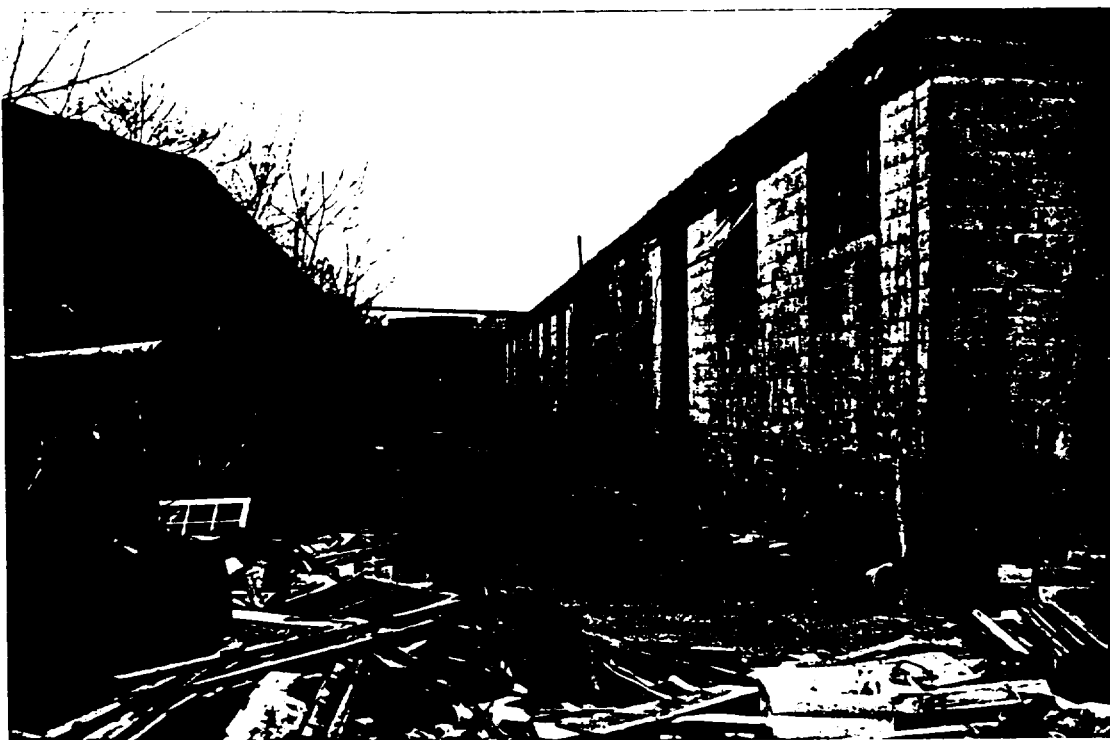
Photograph #40
Scattered Debris
Alley Between Building F & G
